SEISMIC EVALUATION
Of

Beach Cities Health District
514 North Prospect Avenue & Central Plant
Redondo Beach, CA

Nabih Youssef Associates
Structural Engineers
550 South Hope Street, Suite 1700
Los Angeles, California 90071
NYA Job # 17171.00

March 27, 2018

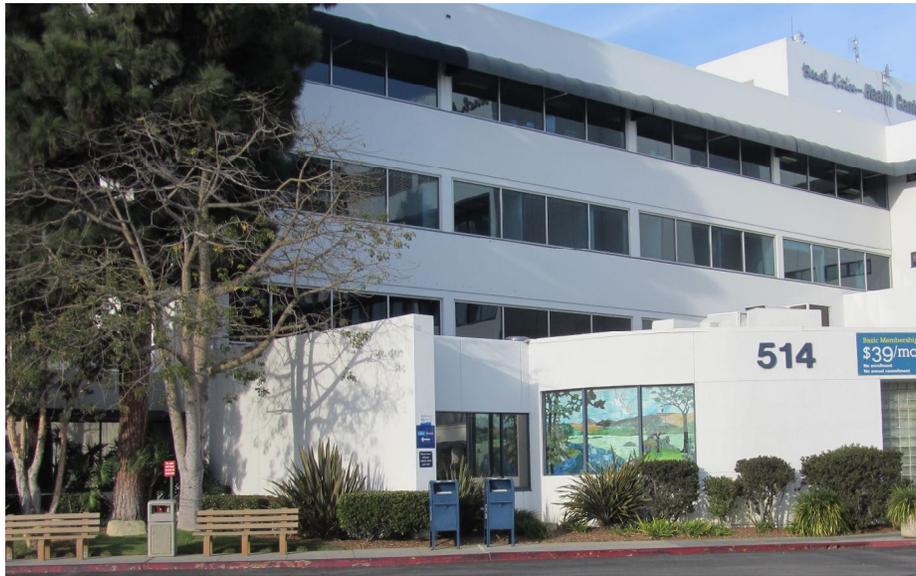
Figure 2 - View of South Side of North Tower

The lateral force resisting system for the north tower consists primarily of concrete shear walls in both directions of the building. There are also deep concrete spandrels framing to concrete columns along the north and south sides of the building that act as moment frames (refer to figure 2). The floors and roof contain concrete slabs that form rigid diaphragms that distribute seismic induced forces to the walls and frames.

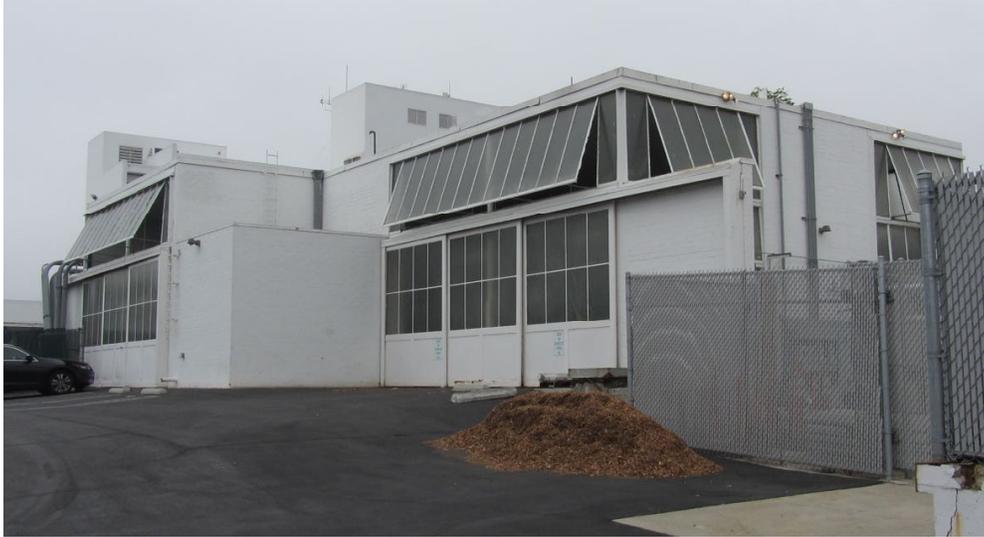
Figure 3 -View of Central Plant

The lateral force resisting system of the central plant consists of reinforced masonry shear walls around the perimeter of the building. The roof consists of a plywood diaphragm and anchors connecting the perimeter masonry walls to the timber framing (refer to figure 3).

- The existing ties between the perimeter reinforced masonry walls and plywood diaphragm are deficient.

- Add new Simpson straps and blocking at the roof to brace the perimeter reinforced masonry.
