SEISMIC EVALUATION

**Beach Cities Health District
Medical Office Building**

510 N. Prospect Avenue
Redondo Beach, CA

January 21, 2020

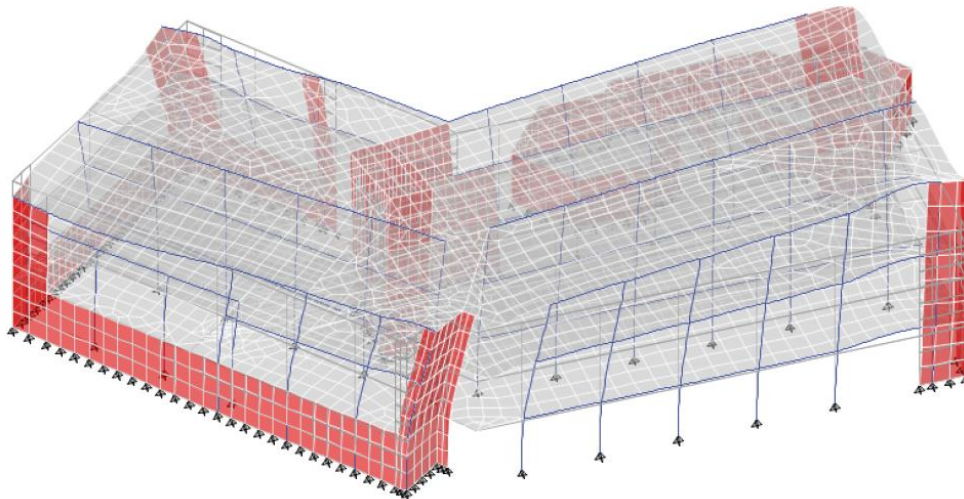
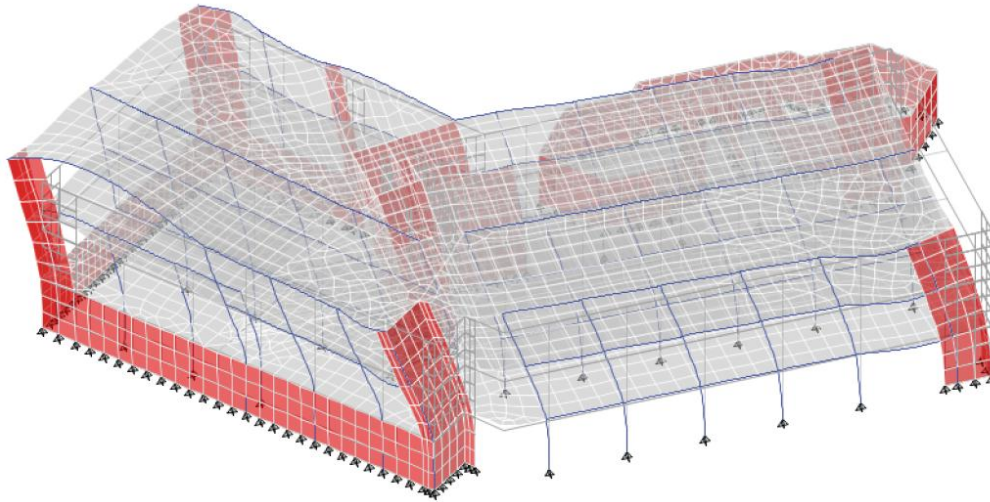
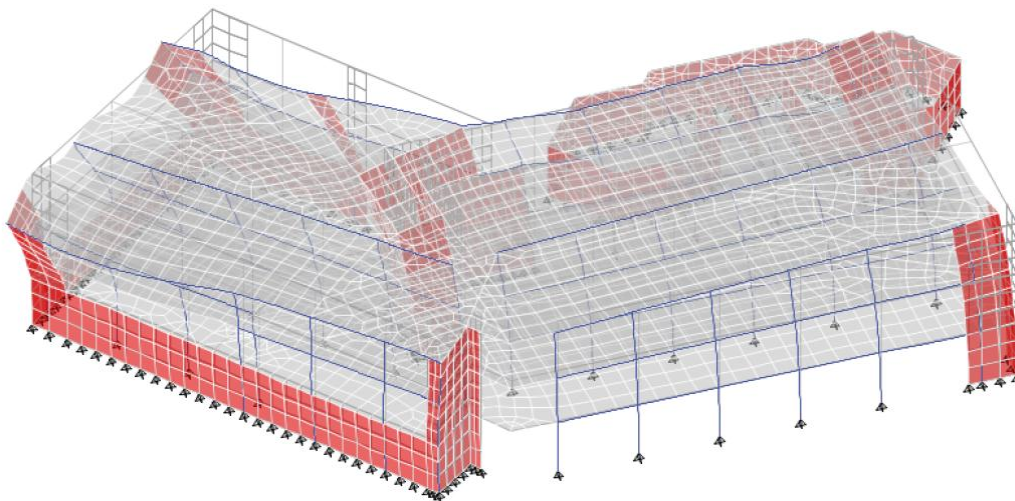
The results of the modal analysis indicate that the lateral force resisting elements of the building are ill distributed resulting in an irregular (torsional) response. Figures 4.3 through 4.5 show plots of the fundamental mode shapes for the building. Table 4.3 summarizes the fundamental periods.

The results of the analysis indicate that approximately 30% of the CMU walls have inadequate shear and/or flexural strength. In addition, approximately 85% of the slab-to-CMU wall connections have inadequate strength to transfer expected seismic forces with average demand-to-capacity ratio (DCR) of 3.0.

- Strengthen select existing CMU walls at perimeter and around elevator core with shotcrete from foundation to roof. At perimeter, shotcrete to be applied to exterior face of existing wall. At elevator core, shotcrete to be applied to outside face of existing wall (not in shaft). Since the existing roof and floors are constructed with pre-stressed pre-cast spancrete planks, planks adjacent to the elevator core need to be removed for the construction of the new shotcrete walls (allowing the placement of continuous vertical reinforcement). The removed planks will be replaced with metal deck and concrete fill supported on new steel beams spanning to existing CMU walls and pre-cast concrete beams.

- Strengthen existing footings at new shotcrete walls. Foundation strengthening at elevator core to include micropiles.
- Strengthen roof and floor diaphragms by removing existing concrete topping slab at select locations and replacing with new reinforced concrete slab.

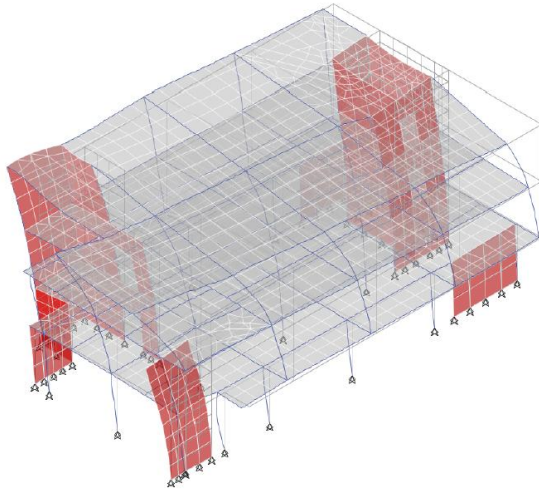
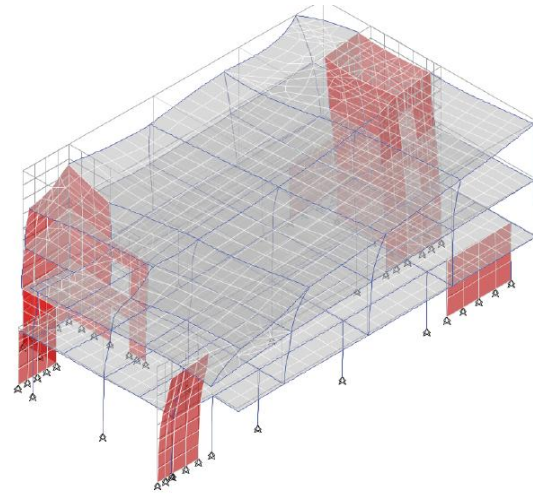
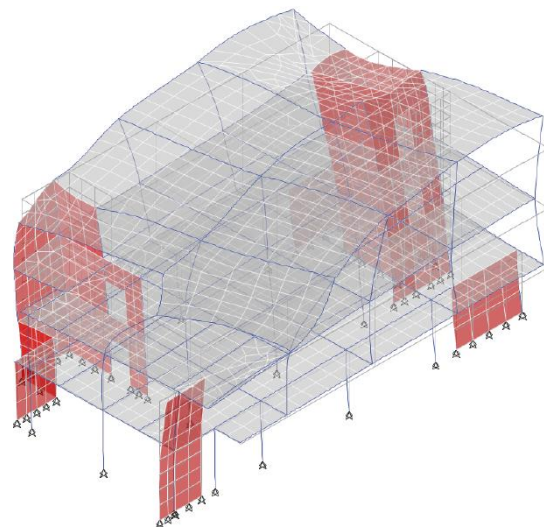
The modal analysis results indicate that the lateral force resisting elements are not uniformly distributed resulting in an irregular (coupled) response. Figures 4.6 through 4.8 show plots of the fundamental mode shapes. Table 4.4 summarizes the fundamental periods.

The results of the analysis indicate that approximately 10% of the CMU walls have adequate shear and/or flexural strength. The plywood roof diaphragm has an extensive cantilever on the south side and there are no chord elements to resist/transfer seismic

loads. The results also indicate that approximately 80% of the slab-to-CMU wall connections have inadequate strength to transfer expected seismic forces with average demand-to-capacity ratio (DCR) of 1.7.

The results indicate that approximately 40% of the footings exceed the allowable soil bearing pressure and 40% of the grade beams have inadequate shear and flexural strength.

- Strengthen existing interior CMU wall with shotcrete from foundation to underside of 3rd floor.
- Strengthen existing footing at new shotcrete wall.
- Strengthen existing footings and grade beams at select locations.
- Strengthen existing roof and floor diaphragm to CMU wall connection with additional drilled and epoxied dowels.
- Strengthen existing steel beam to beam connections at roof level by welding steel shear tab plate to beam web.
