SEISMIC EVALUATION

Beach Cities Health District - Parking Structure

512 N. Prospect Avenue
Redondo Beach, CA

January 17, 2020

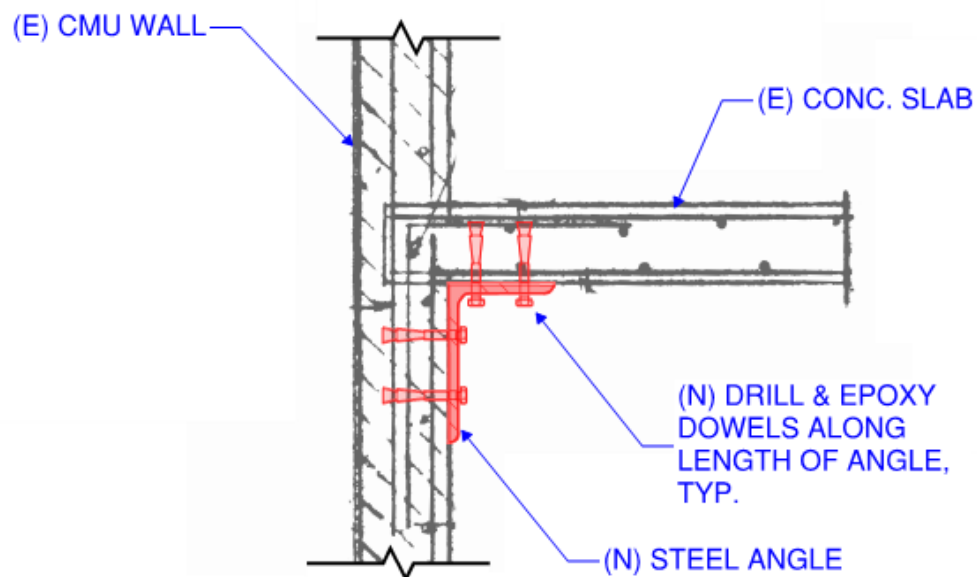
Figure 6.1 - Slab-to-CMU Wall Connection Strengthening

The methodology of ASCE 41-17, Seismic Evaluation and Retrofit of Existing Buildings, was used to evaluate the seismic performance. The results indicate that the slabs and CMU walls have adequate shear and flexural strength. However, the slab-to-CMU wall connections have inadequate strength to transfer expected seismic forces with average demand-to-capacity ratio of 1.2.

The results of the analysis indicate that the slabs and CMU walls have adequate shear and flexural strength. However, the results also indicate that the slab-to-CMU wall connections have inadequate strength to transfer expected seismic forces with average demand-to-capacity ratio (DCR) of 1.2.

- Add new steel angles to underside of slab at CMU walls at select locations of roof and 2nd parking levels. Angles to be connected to slabs and walls with drilled and epoxy dowels. Figure 6.1 shows a sketch of the slab-to-wall connection detail.
