Beach Cities Health District  
514 North Prospect Avenue  
Redondo Beach, CA 90277

**Report: Seismic Risks – Beach Cities Health District MOB and Parking Structure  
510 and 512 North Prospect Avenue, Redondo Beach, CA 90277**

### 2.1 Design Review Notes, Medical Office Building (MOB), 510 North Prospect Avenue

### 2.3 Design Review Notes, 512 North Prospect Avenue Parking Structure

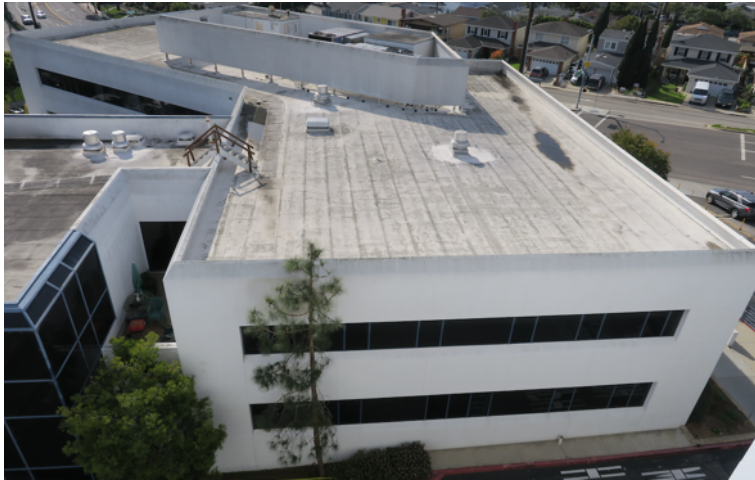
Fig 10 – 1976 MOB Exterior

<i>Condition:</i>	Good condition was observed in the locations inspectable. Better structural and nonstructural condition was observed than in the old hospital (514 N. Prospect).
<i>Architectural Notes:</i>	(1976 Original Building) Lightweight exterior panels with "marblecrete" finish and ribbon windows.  (1979 Addition) Glass-clad at 2 <sup>nd</sup> and 3 <sup>rd</sup> floor.
<i>Equipment Notes:</i>	HVAC equipment is secured to the roof

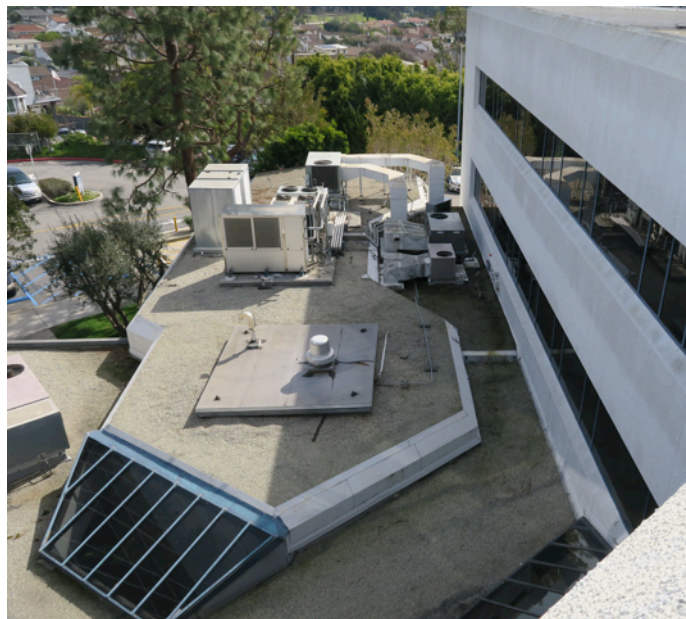
Fig 12 – 1976 MOB Exterior & X-Ray Roof

The “X-Ray Room” is shown in drawings for the Original Medical Office Building (1976). It is a concrete building, 13’-10 feet tall to the top of the roof slab, with massive reinforced concrete walls to provide shielding. The minimum wall thickness is 2 feet, and walls at the ends of the building reach a thickness of nearly 9 feet. The roof is a 2-foot thick flat reinforced concrete slab. A 6” thick reinforced slab-on-grade forms the floor. It is essentially a rigid box structure, with very low structural vulnerability. It appears to be structural connected to the original MOB. The connecting slab uses spancrete planks and a topping slab, but does not appear to be specially reinforced to transfer loads to the X-Ray building. Therefore, differential movements between the mid-level MOB floor and X-Ray building roof may cause damage to the connecting slab. HVAC equipment is anchored to the roof and to the slab interconnecting it to the original MOB.

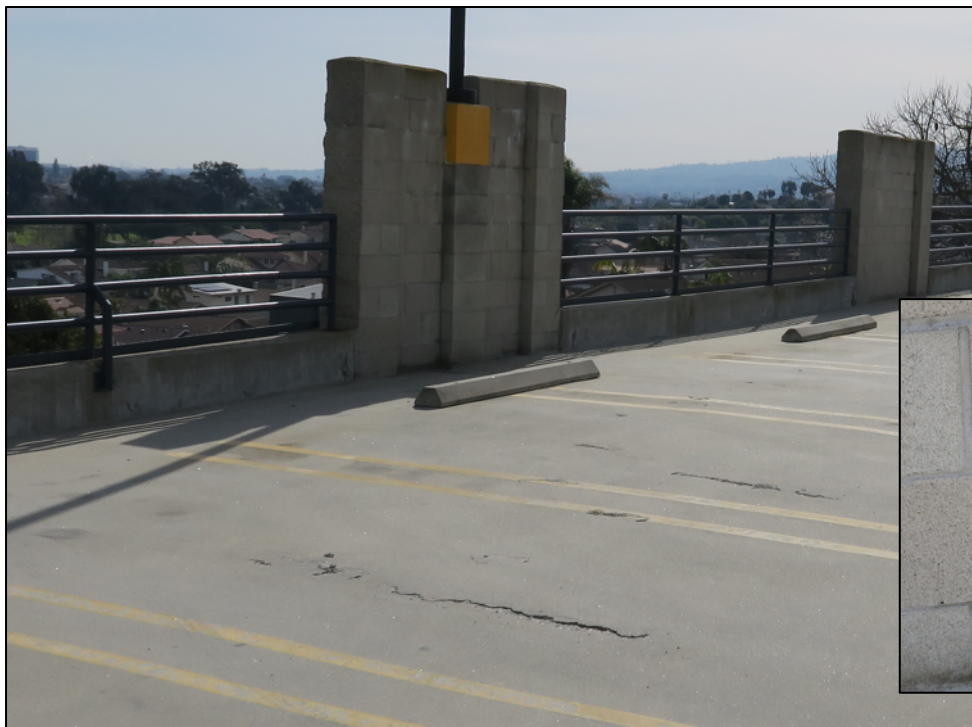
*Cracking at  
Pier/Spandrel Joint*

no seismic joint between the tall, narrow CMU wall piers and the concrete spandrels at the edge of the slabs. Cracking is observed where the spandrel abuts the CMU walls.

The parking structure was designed to a more recent code (1985 UBC), and NYA found it to be a good structure. The sole concern was for a slight overstress in the slab-wall connections for BSE-2E ground motions. NYA recommended reinforcing slab-to-wall connections to meet the BSE-2E ground motions, under which they are 20% overstressed. We note that the BSE-2E ground shaking is stronger than the current code levels, so the overstress most likely does not exist for the design basis earthquake (DBE). We interpret this to mean that the parking structure is close to conformance with current codes and should be expected to provide stability and life-safety performance near to that of current code. Our stability screening methods indicate that the parking structure has about a 10% probability of collapse in the 2,475-year recurrent ground motions, consistent with the Maximum Considered Earthquake under ASCE 7 and IBC – consistent with current code life-safety performance.

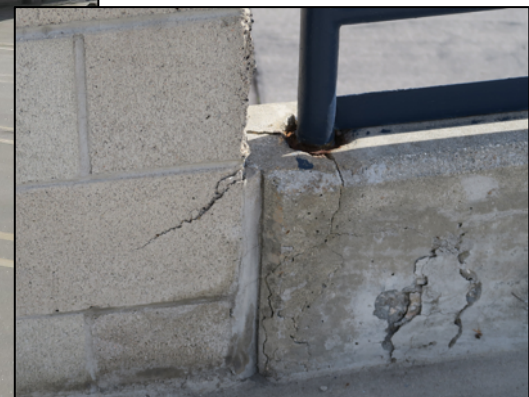
**Figure 14 – Exposed Rebar, Parking Structure Top Deck; Narrow Masonry Piers and Spandrels**

Tall narrow CMU piers are seen along the long side. Thick slabs and perimeter spandrels may make this exhibit unintended frame action. NYA found that the slab-to-wall connections are slightly overstressed.

The structure has some exposed rebar at the top of slab in a few locations from inadequate cover in the original construction. There is
