SEISMIC EVALUATION

**Beach Cities Health District
Medical Office Building**

510 N. Prospect Avenue
Redondo Beach, CA

January 21, 2020

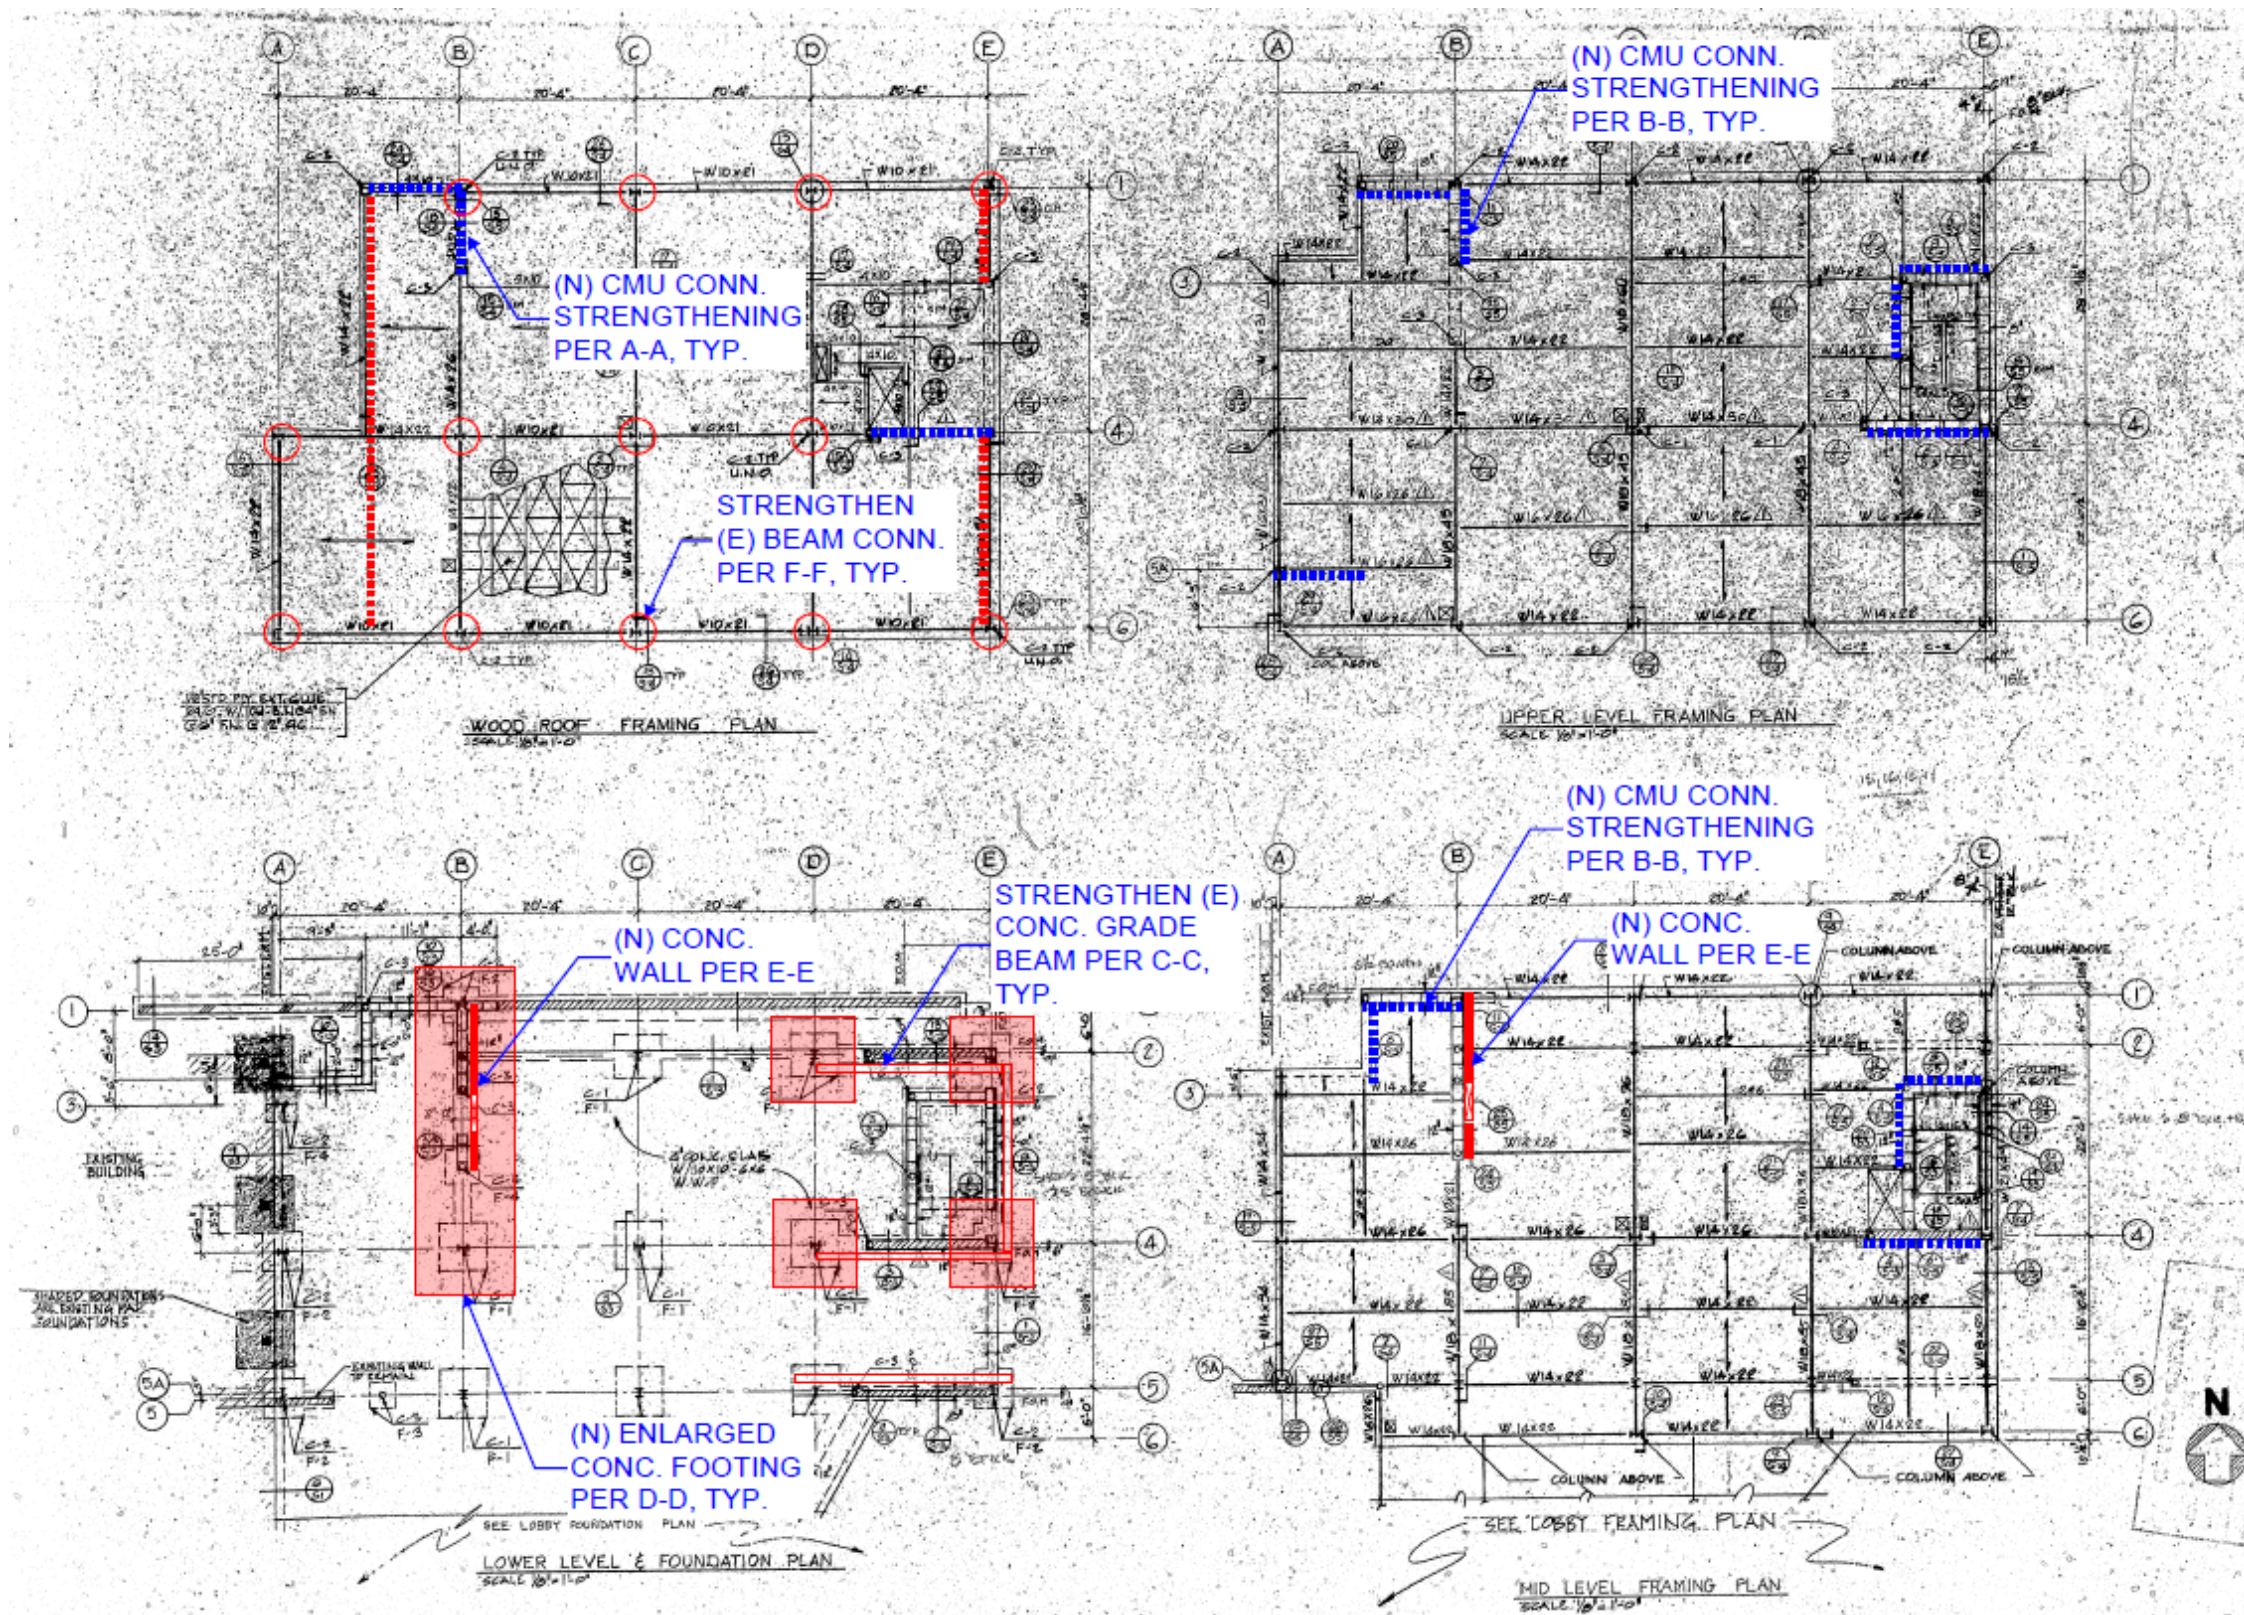
Framing Plans

The plywood roof diaphragm of the 1979 Addition has an extensive cantilever on the south side and there are no chord elements to resist/transfer seismic loads. In addition, approximately 40% of the footings and grade beams of the 1979 Addition have inadequate strength.

- Strengthen existing interior CMU wall with shotcrete from foundation to underside of 3rd floor.
- Strengthen existing footing at new shotcrete wall.
- Strengthen existing footings and grade beams at select locations.
- Strengthen existing roof and floor diaphragm to CMU wall connection with additional drilled and epoxied dowels.
- Strengthen existing steel beam to beam connections at roof level by welding steel shear tab plate to beam web.

ADD (3) ADD'L DRILL
& EPOXY DOWELS
BTW. (E) ANCHORS
