SEISMIC EVALUATION

Beach Cities Health District - Parking Structure

512 N. Prospect Avenue
Redondo Beach, CA

January 17, 2020

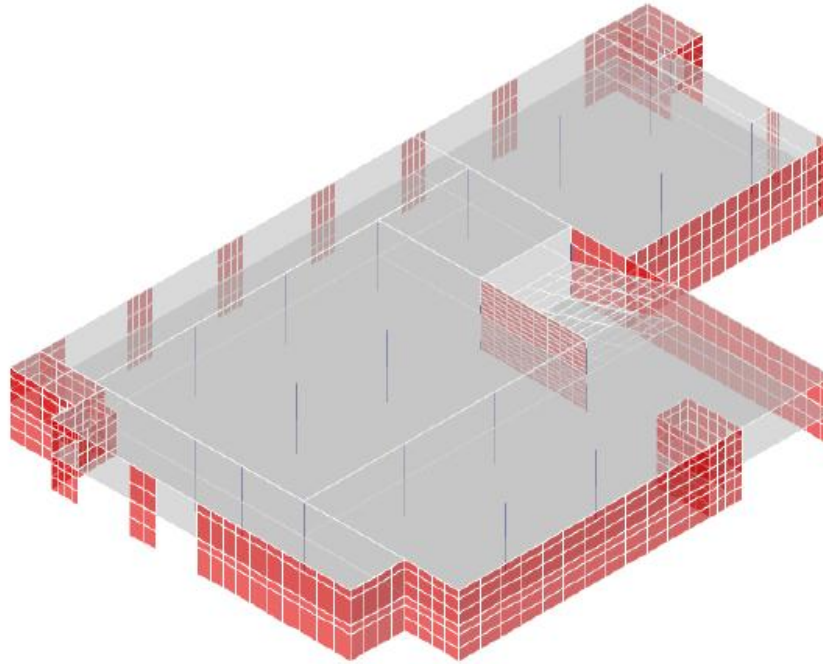
Figure 4.1 – Plot of ETABS model

A three-dimensional computer model of the parking structure was developed using ETABS 2017, developed by Computers & Structures, Inc. The model included all elements that significantly contribute to the lateral force resistance of the garage: these include the concrete slab parking decks, and reinforced masonry walls/piers. The

concrete slab parking decks were assumed to behave as semi-rigid diaphragms. The concrete columns were included in the model to provide vertical support to the concrete slabs. The seismic base of the garage was assumed to be at the first parking level. Figure 4.1 shows a plot of the ETABS model.

The results of the analysis indicate that the slabs and CMU walls have adequate shear and flexural strength. However, the results also indicate that the slab-to-CMU wall connections have inadequate strength to transfer expected seismic forces with average demand-to-capacity ratio (DCR) of 1.2.

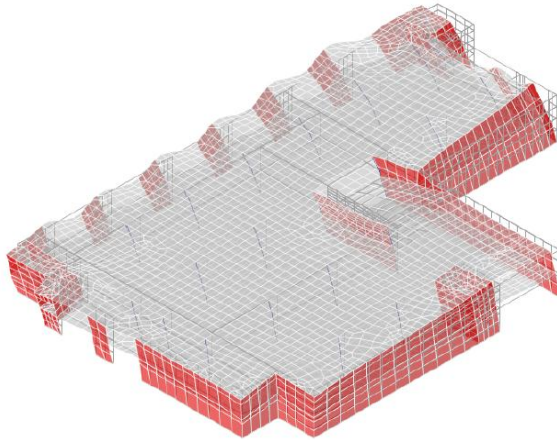
Figure 4.2 - N-S Translational Mode

Modal analyses were performed to determine the dynamic characteristics of the building. The results indicate that the lateral force resisting elements are well distributed and provide a regular response. Figures 4.2 through 4.4 show plots of the fundamental mode shapes. Table 4.3 summarizes the fundamental periods.
